Environmental Monitoring Report

Project Number: 51077-003
Quarterly Report (October - December 2023)
February 2024

Maldives: Greater Male Waste-to-Energy Project

Part A: Main Report

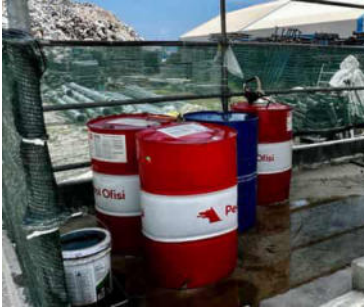
Fuel Storage on site	Fuel storage on site needs to be improved and is not adequate (12 th October 2023).

Sheltered area with retaining wall and proper leak proof floor to be constructed.	Fuel storage area has been constructed and in use. Closed Date: 24 th October 2023

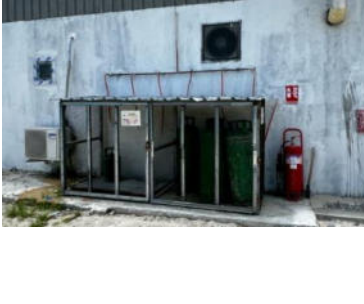
LPG Gas Cylinders used in Kitchen area	The piping and placement of the valves on the LPG gas cylinders for the kitchen were not practical and requires immediate corrective measures. (14 th December 2023).

To ensure, that valves should be approachable and closed easily in case of a leak.	Corrective measures are taken and the emergency valve is now accessible. Closed Date: 20 th December 2023

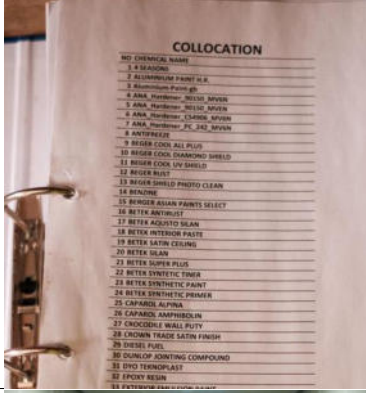
Aspect	Site Observation / Finding	Site photographs	Action to be taken	Current status	Date of completion
Chemical Storage Area	Inadequate MSDS records. Date of Observation was 11/10/2023

To update and ensure all chemical stored have valid MSDS. MSDS shall be visible for all chemical storage areas.	MSDS in the storage area is updated Closed date: 9/11/2023	
Staff Accommodation	No emergency light on escape doors in office and in accommodation area of camp site 11/11/2023

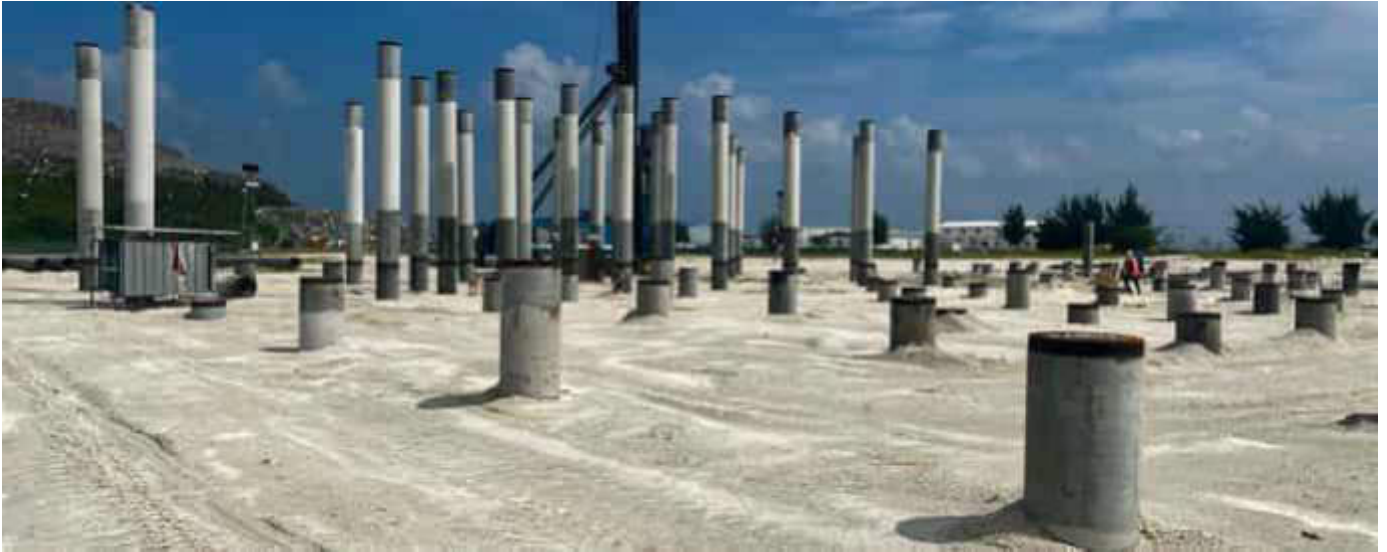
Photo 44 12/10/23 12:06hrs.

Damaged pile within the process building area, yet to be cut to length.

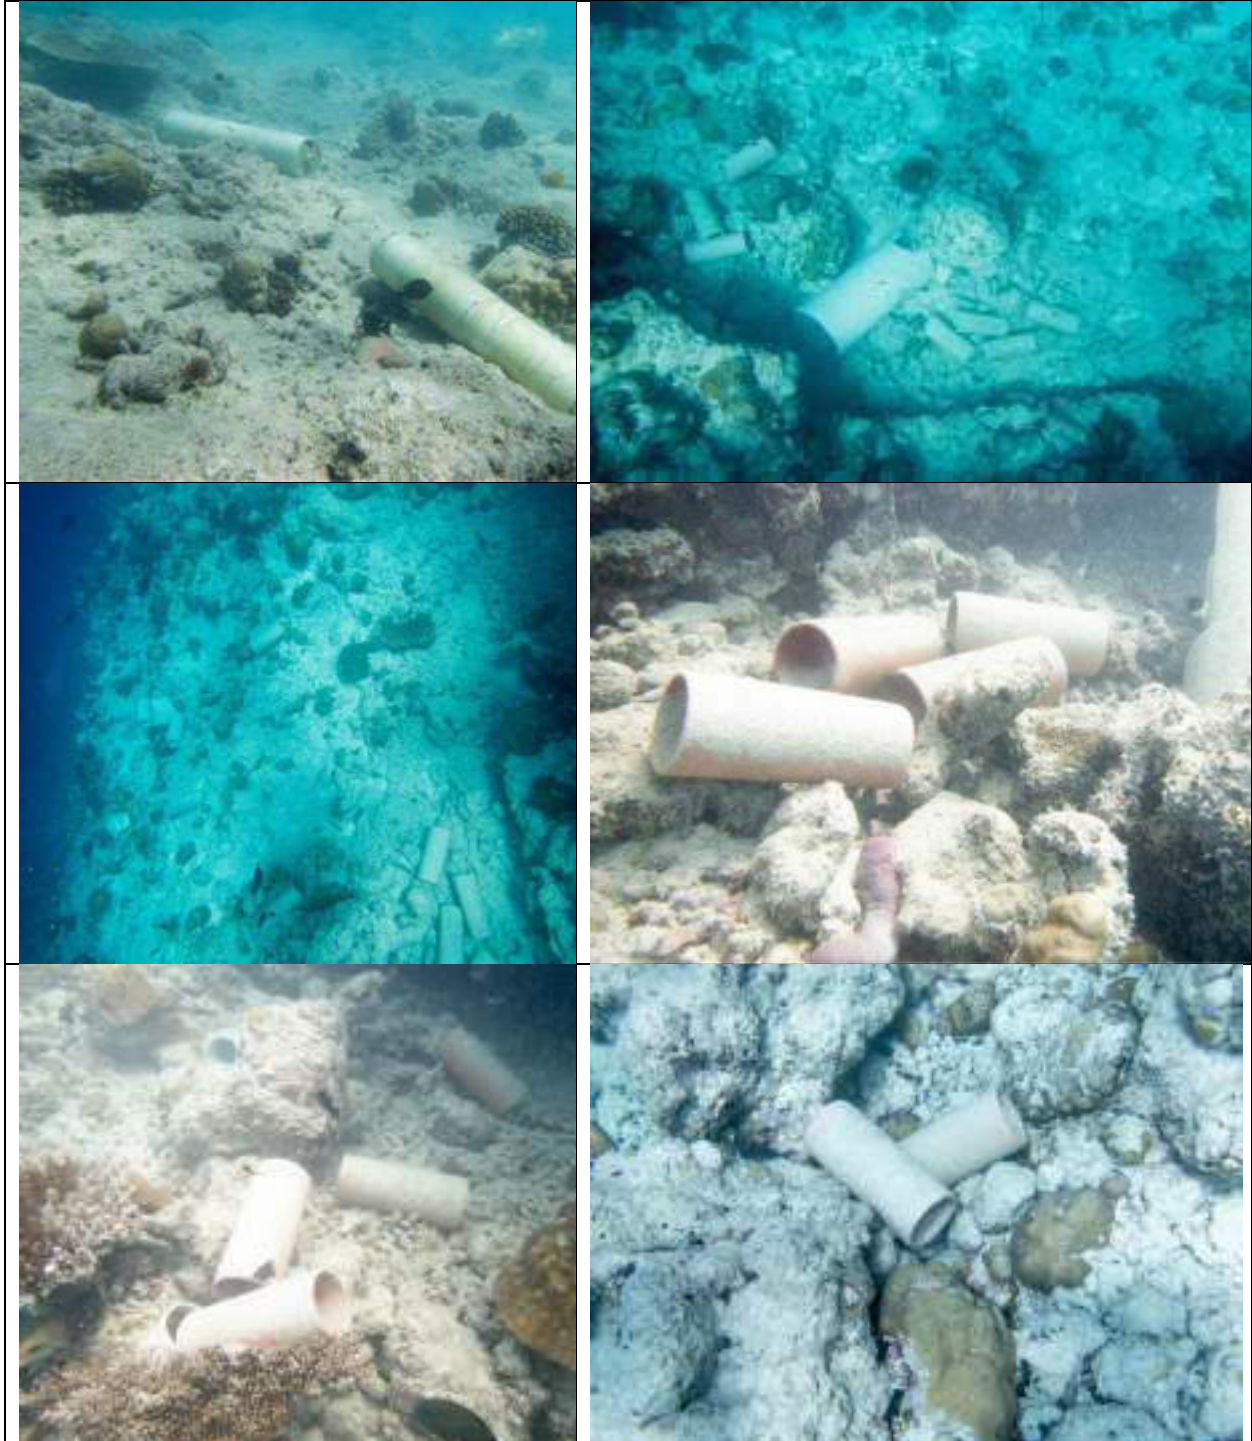
Figure 10. Large number of cut pieces of PVC pipes were found in the monitoring sites.
