# Environmental Monitoring Report

Project Number: 51077-003  
Quarterly Report (July-September 2024)  
October 2024

## Maldives: Greater Male Waste-to-Energy Project

### Part A: Main Report

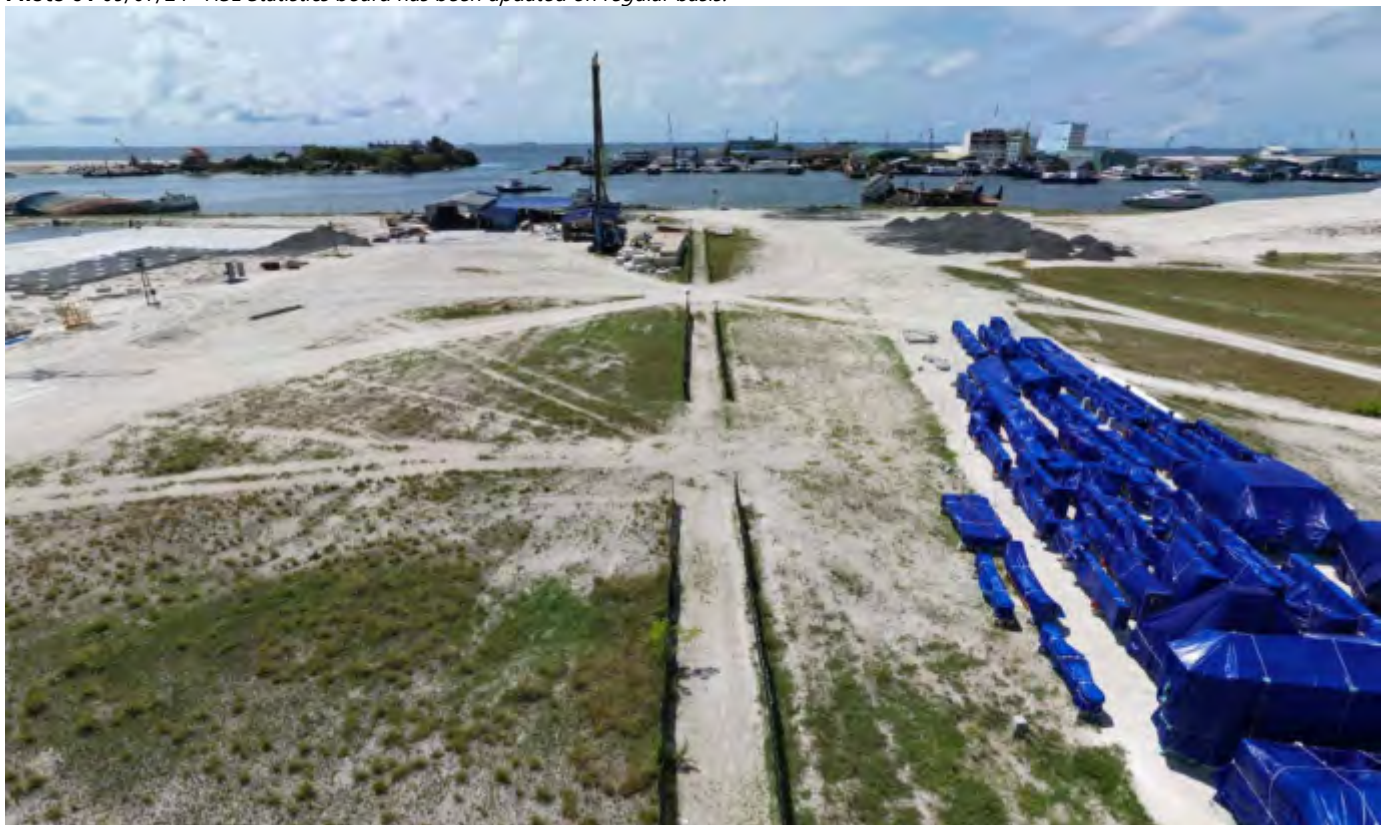
Photo 02 09/07/24 – The walkpath from the construction camp to the construction area is kept clean and free of tripping hazards.

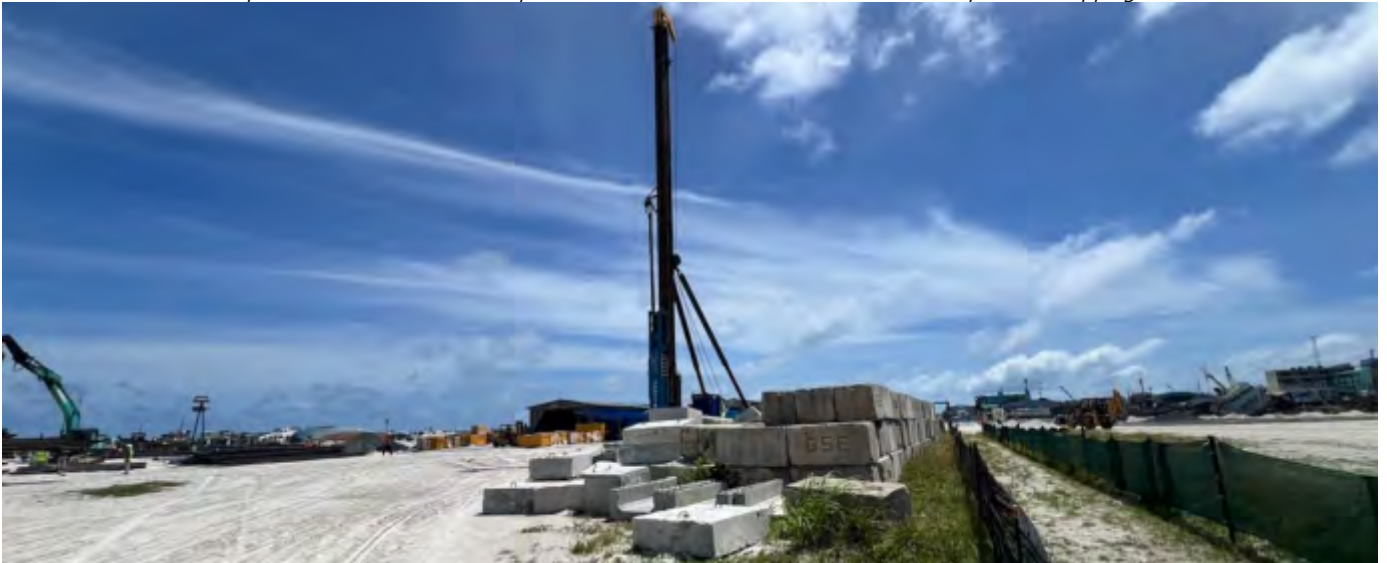
**Photo 02** 18/07/24 – Some equipment and material remain on site from the spun pile driving work, its advised to remove from site if the material is no longer required.

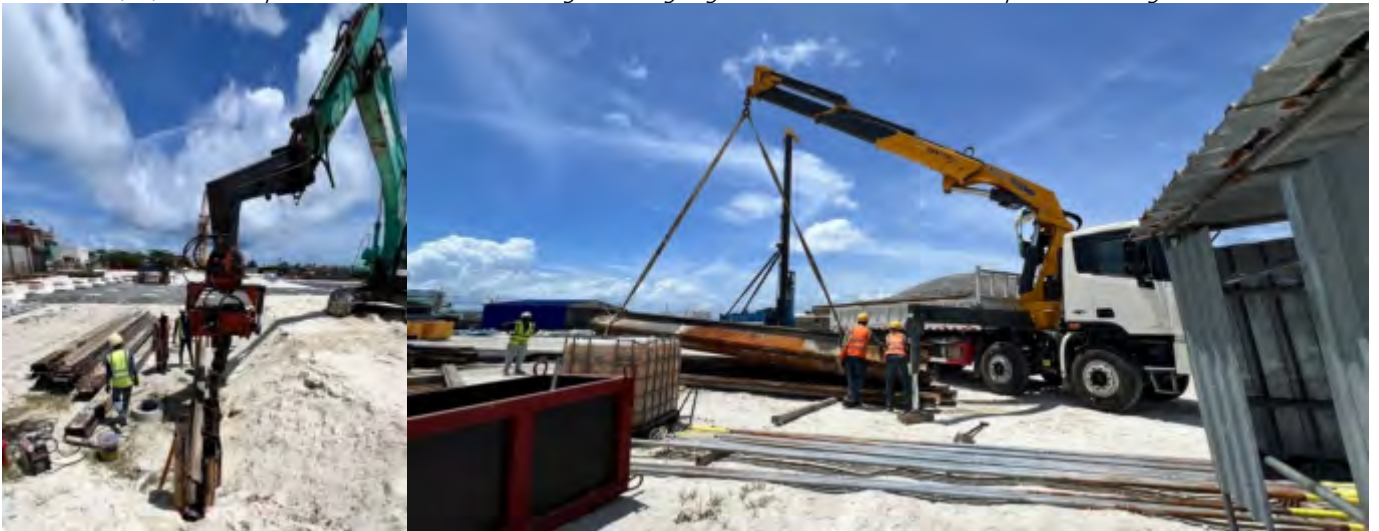
**Photo 05** 18/07/24 – Sheet pile works are ongoing for the turbine foundation area.

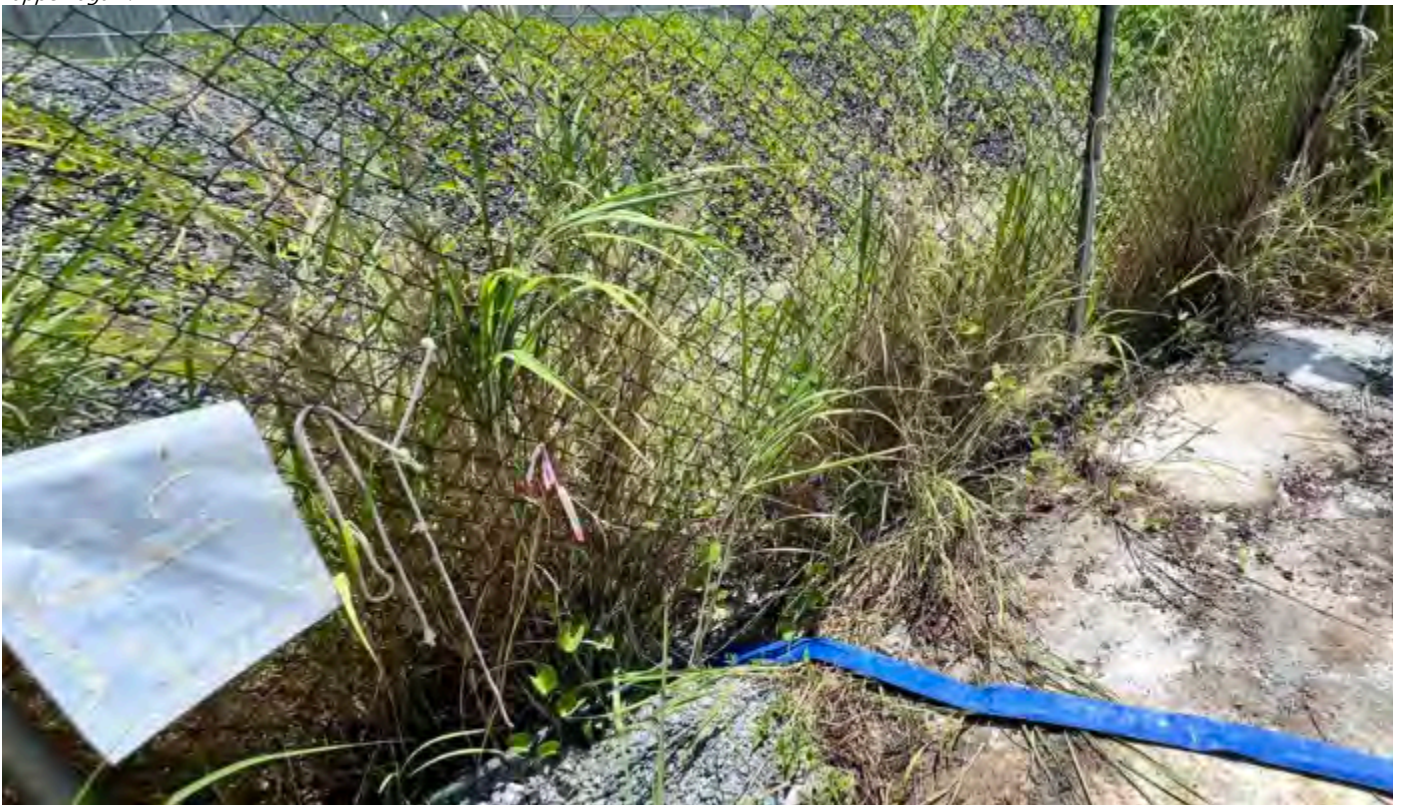
**Photo 17** 18/07/24– A pump and pipe line was seen from the concrete wash out area retention tank to the adjacent site, this has been brought to immediate attention of the DBO, EPC and Villa subcontractor and instructed to stop this as it is violation of regulations and ensure this doesn't happen again.

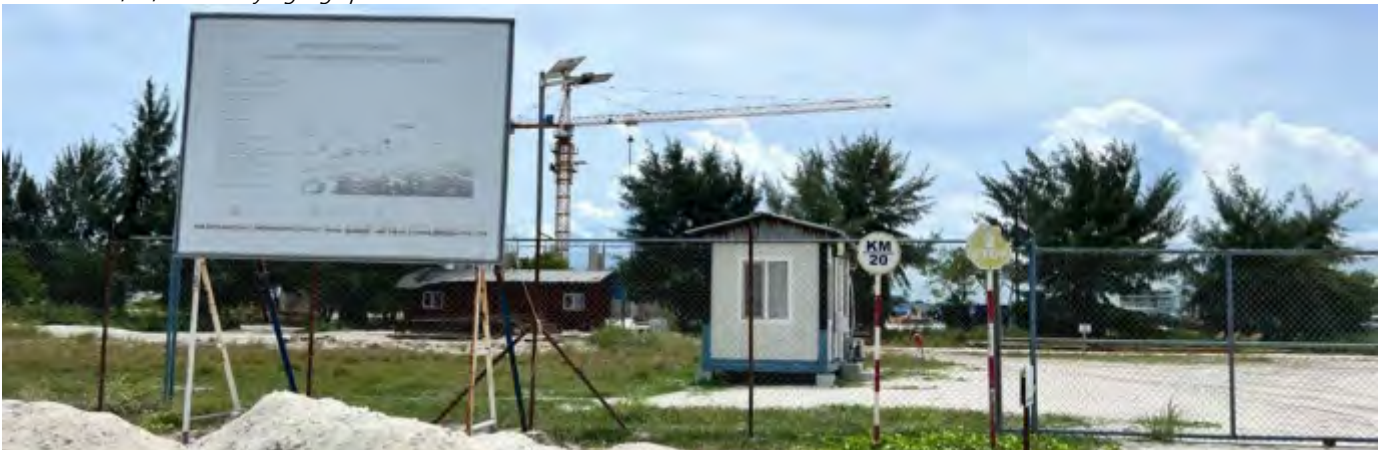
**Photo 09** 25/07/24– Safety signage placed at the main entrance to the site.

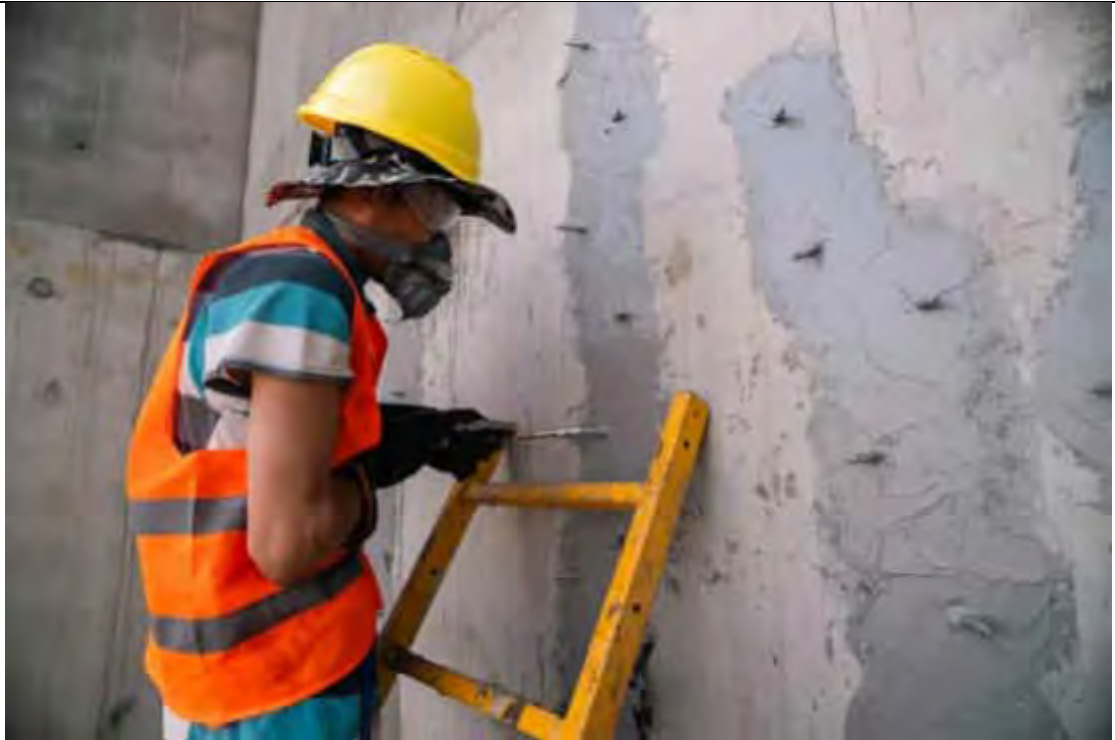
13

CRACK REMEDIAL WORK FOR EXTERNAL BUNKER WALL.

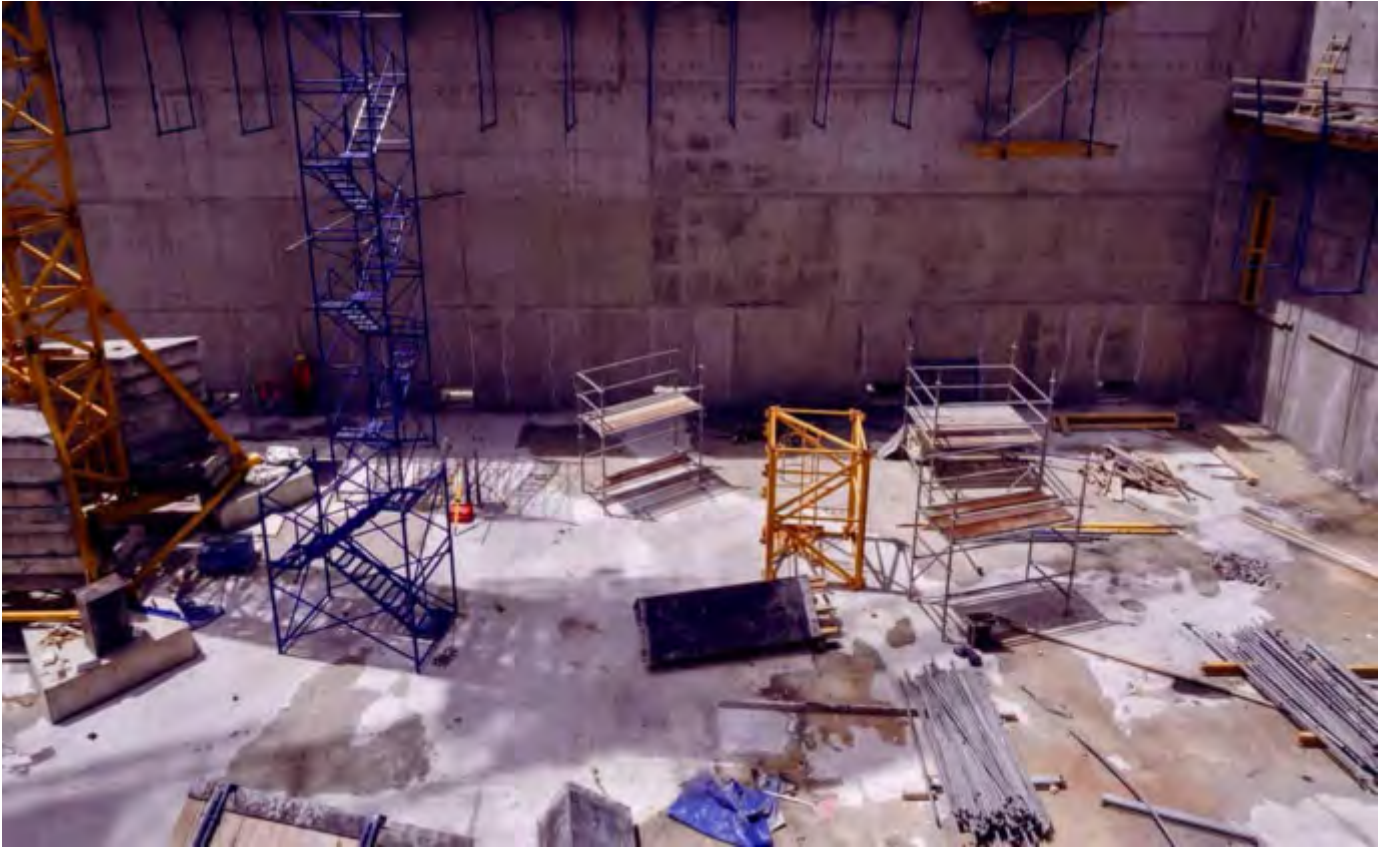
**Photo 10** 13/08/24 Bunker inside view of Area 1 and 4, crack repair work on Wall D has been completed.

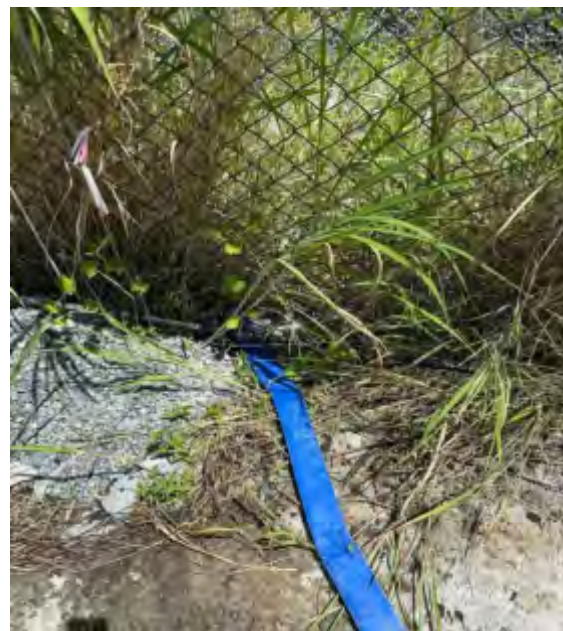
**Discharge of Waste water from sedimentation tank in batching plant to adjacent land owned by third party observed during site visit in July month for inspection**

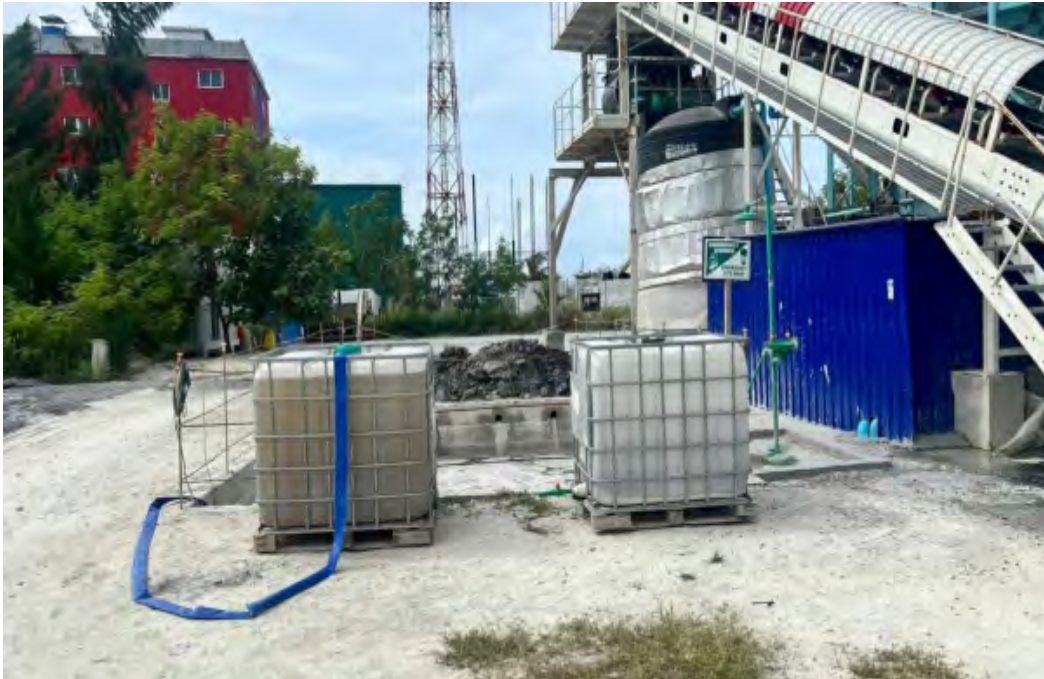
**Discharge of Waste water from sedimentation tank in batching plant observed during site visit in July month for audit. Though tank was placed to store waste water, but no record of transportation was made available to verify the claim made by DBO.**

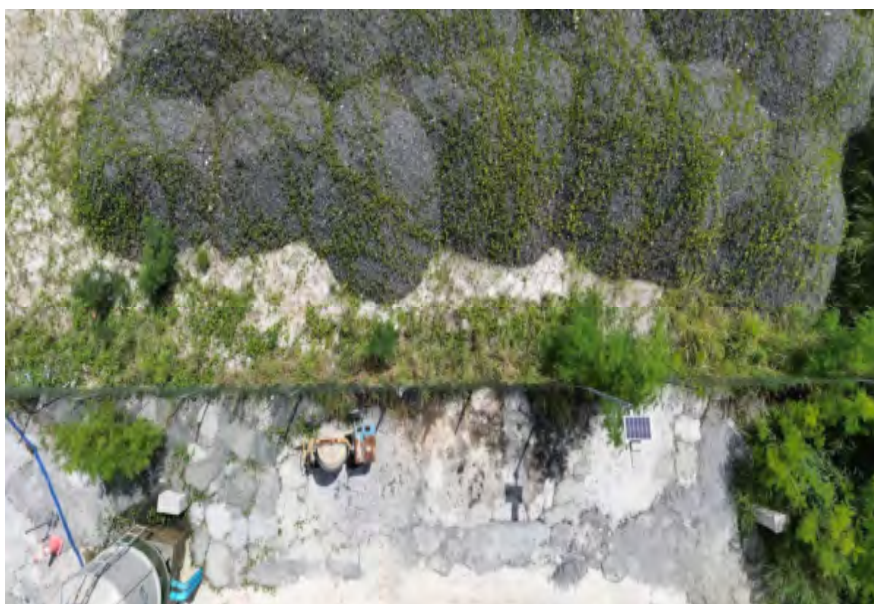
**Accumulated sludge on adjacent land owned by third party where waste water from sedimentation tank in batching plant area is discharged.**

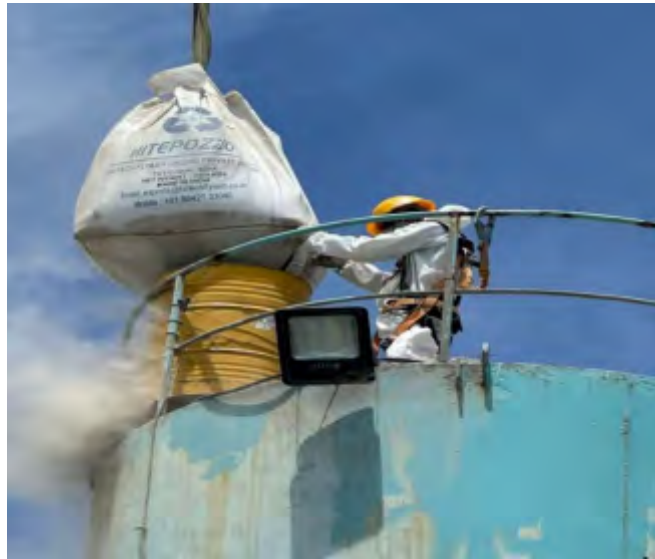
**Figure 13: Inadequate Mask found in batching plant area**
