Environmental Monitoring Report

Project Number: 51077-003
Quarterly Report (January-March 2025)
April 2025

Maldives: Greater Male Waste-to-Energy Project

PART A: Main Report

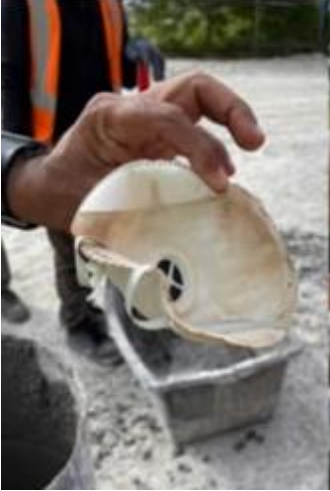
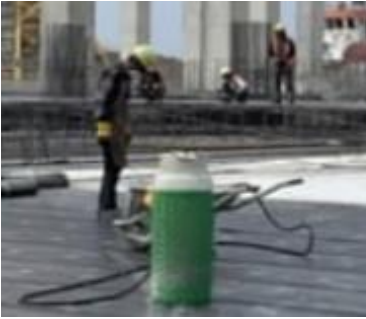
Aspect	Site Observation / Finding	Site photographs	Action to be taken	Current status	Close out photo
PPE Use	<p>Some workers were found without the appropriate masks / masks which required replacement</p> <p>Workers found without safety goggles during pouring of cement into the columns</p>

<p>Ensure use of all required PPE by all workers.</p> <p>Ensure PPE is in good condition.</p>	<p>Contractor has provided refresher trainings on PPE use and committed to improving site monitoring. Observations of improper usage of PPE has decreased following trainings and inspections. However, non-compliances have been observed and ensuring proper usage of PPE is a continuous process.</p>

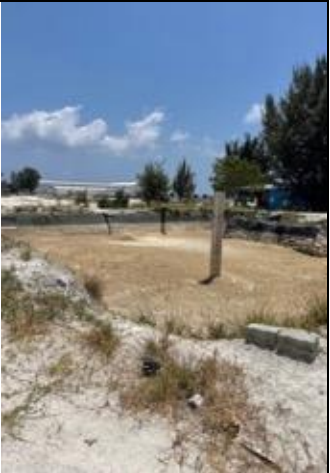
Aspect	Site Observation / Finding	Site photographs	Action to be taken	Current status	Close out photo
Dewatering	<p>Dewatering without renewal of the permit from URA</p> <p>14/11/2024</p>

Permit to be obtained	Currently, no dewatering is taking place and the pond has dried up. The DBO informs that the permit application is tied to ongoing activity itself rather than having been obtained prior to its commencement.

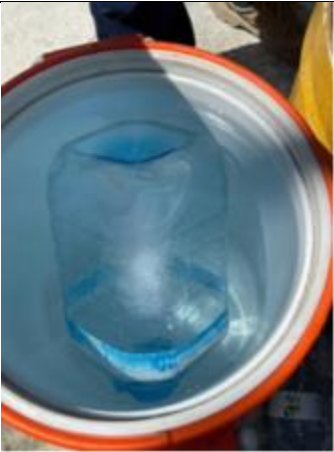
Potable Water	<p>Frozen plastic water bottle placed in water cooler</p> <p>Re-used, uncovered jam bottles placed near water cooler to be used as cups</p> <p>4/12/2024</p>

Improve drinking water conditions	<p>Management has provided refillable water bottles for each worker and improved the water shelters.</p> <p>Workers have easy access to a supply of clean/potable water in adequate quantities</p>

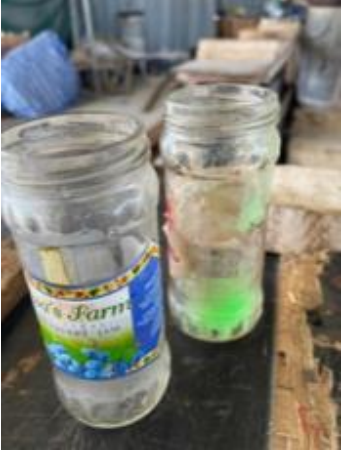
A wheelbarrow was being used to transport drinking water to workers stations and the premises where the water coolers were filled. The dispensing station was unhygienic and there was no dish washing

Aspect	Site Observation / Finding	Site photographs	Action to be taken	Current status	Close out photo
	liquid, brushes or sponges to clean the bottles. The refilled water bottles were carried out in a very dirty wheel barrow 4/12/2024

Ensuring hygienic practices are followed when handling and transportation of drinking water.	Improved conditions and provision of a clean wheelbarrow for transportation.

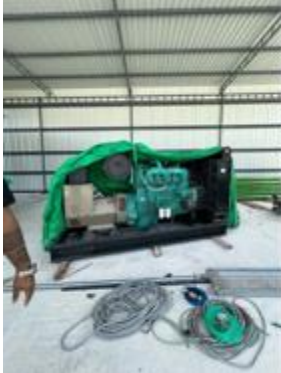
Aspect	Site Observation / Finding	Site photographs	Action to be taken	Current status	Close out photo
	High noise levels at other generator sets located within the site, including new generator sets at the bunker area.

Noise mitigation measures are required.	Tin enclosure is being placed around the new generator sets.	Not closed
Safety signage and safe access	<p>Inadequate safety caution, information and awareness signage.</p> <p>19.03.2025</p> <p>Obstructed accessways.</p>

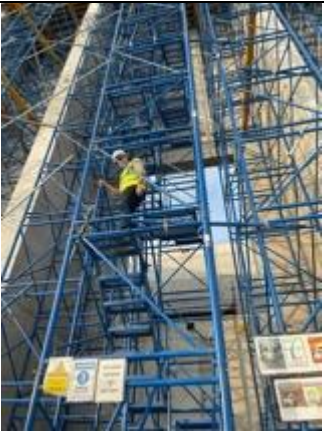
Aspect	Site Observation / Finding	Site photographs	Action to be taken	Current status	Close out photo
Erection of Scaffolding and working platforms	<p>Incompetent scaffolding inspectors without professional experience. The issue has been raised since last November 2024.</p> <p>19.03.2025</p>

<p>(November 2024)</p>	<p>Ensure there is a system in place for inspection of scaffolding.</p> <p>Develop the required SOPs/ guidelines required for inspection and dismantling.</p>	<p>Not Closed.</p> <p>Majority of the scaffolding has been taken down as it is not required currently. Scaffolding tags have been provided.</p> <p>Specialized training conducted for 3 scaffolding inspectors in Sri Lanka by PWC. 2 scaffolding – one from HSE and one from construction side went under training as scaffolding supervisors. 23 scaffolders trained.</p> <p>The Contractor has informed that competent scaffolding inspectors will be on site in August 2025.</p>

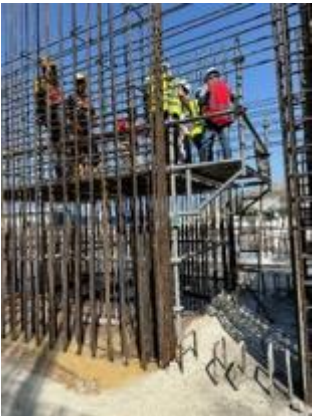
<p>Unsafe conditions at the working platforms with inadequate safety tags and no barricades for platforms under construction.</p>

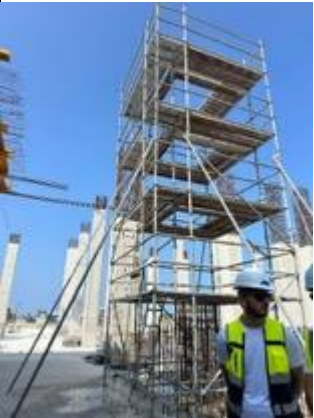
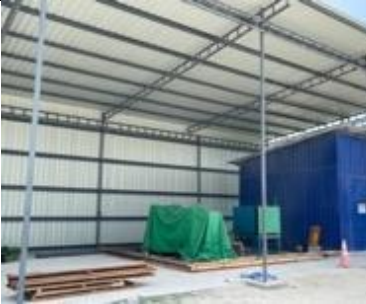
Spill Containment	At the Batching Plant, spill containment for the diesel gensets was not included and set standards are not adhered to

Spill containment to be provided	Completed. Secondary containment has been provided.

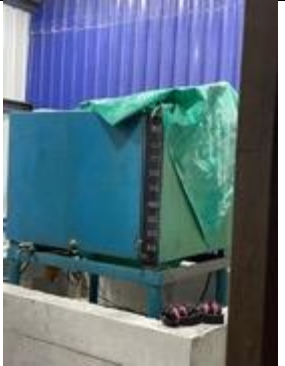
Aspect	Site Observation / Finding	Site photographs	Action to be taken	Current status	Close out photo
Chemical Storage	<p>Spill containment for the chemical warehouse and acquisition of MNDF inspection and approval for the chemical storage needs to be initiated</p> <p>19.02.2025</p>

<p>MNDF inspection and approval for chemical storage.</p> <p>Display essential information at the storage area.</p>	<p>MNDF inspection and approval of the chemical storage process is pending</p> <p>Regular inspections are conducted, specifically for "Chemical Store Inspection" and "Spill Kit Inspection" measures to prevent any spillage or leakage that could impact the surrounding environment.</p> <p>Awareness sessions conducted to train workers/operators in the safe handling of chemicals</p>

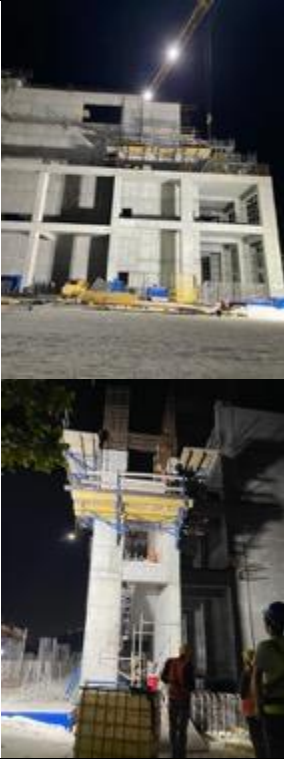
Aspect	Site Observation / Finding	Site photographs	Action to be taken	Current status	Close out photo
Illumination	The west side of the bunker and walkway to the bunker does not have adequate illumination.

Installing supplementary lighting, such as tower lights, in areas requiring adequate illumination.	<p>Additional lights have been ordered for required low illuminated areas.</p> <p>Work was conducted at night mostly during March (in Ramadan).</p>	Not closed
Registration	Registration is required for remaining vehicles and diesel generator sets.

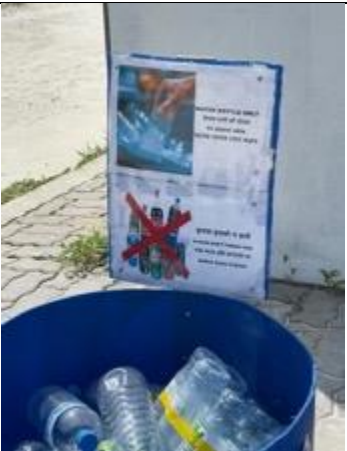
None required.	N/A	N/A
Recycling of plastic bottles	plastic bottle interception with Parley Maldives has been initiated in December 2024.

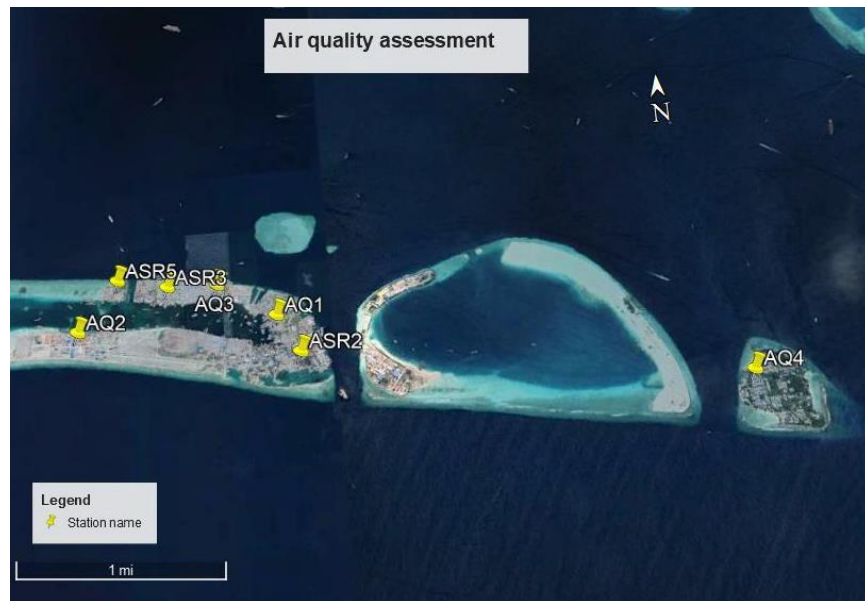
Figure 3: Ambient Air Quality Sampling Stations

33. Ambient air quality sampling was conducted at seven locations: 6 locations at Thilafushi (AQ1, AQ2, and AQ3 identified as baseline stations in the EIA and the ASR2, ASR3 and ASR5 based on the AERMOD study in the EIA), and one location at Villingili (AQ4) as control station. Figure 3 shows the ambient air quality sampling stations. Table 17 gives the description of the sampling stations while Table 18 shows the results of ambient air quality sampling. TSP levels reported for ASR3 could possibly be a reporting error.

Location	Description	Distance to Project Site (WtE facility construction) meter
AQ1	Represents dense industrial area	650
AQ2	Represents dense industrial area	1,000
AQ3	Represents dense industrial area	500
ASR2	Represents dense industrial area	700
ASR3	Represents dense industrial area	500
ASR5	Represents dense industrial area	1,000
AQ4	Represents residential area with moderate urbanisation	4,500

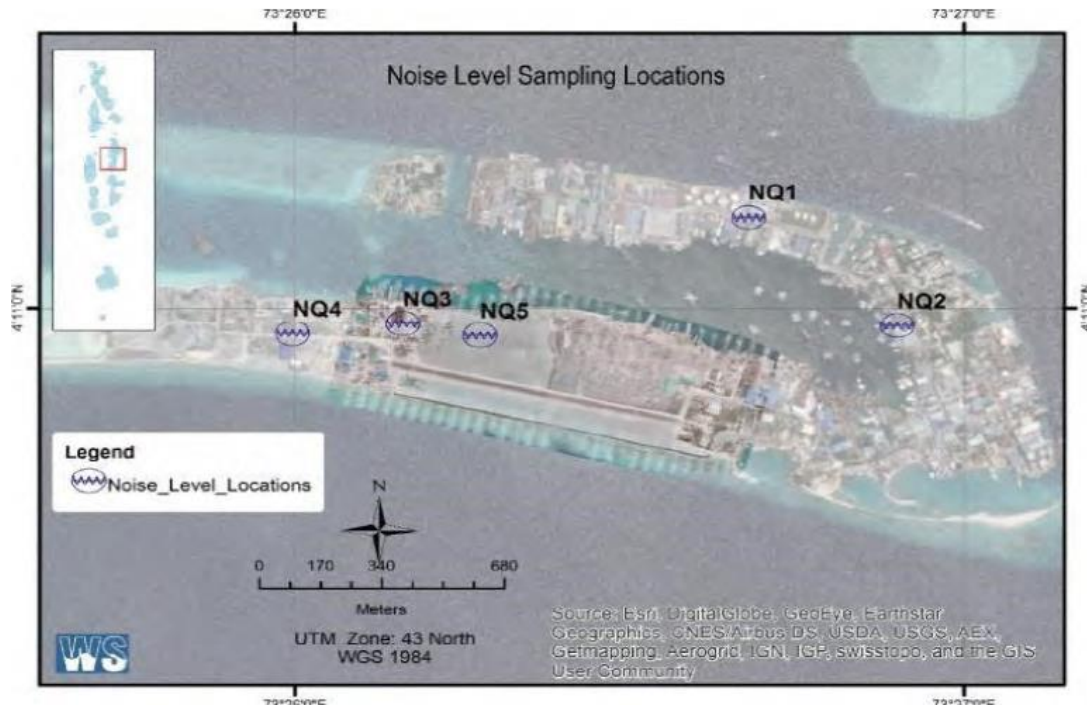
Figure 4: Noise Sampling Stations

37. Ambient noise level measurements were conducted from, 18 to 19 January 2025, 24 to 25 February 2025, and 23 to 24 March 2025, at five sampling stations identified in the EIA (July 2020). These are NQ1 to NQ5 (refer to Table 18 for description of the sampling stations and Figure 4 for location map). Thilafushi is considered an industrial area and the EPA has no noise level standards, thus, results of ambient noise level measurements were referred to the WB-IFC EHS Guidelines April 2007 (Table 1.7.1) of 70 dBA for both daytime and night-time. Hourly noise levels were measured during daytime and night-time using a handheld instrument. Results of noise sampling are presented in Table 20.

39. Results of ambient noise levels were found to be within the applicable standards for commercial and industrial areas during the reporting period except at NQ3 during day time in February 2025 and night time in March 2025. This is due to construction activities within project site as NQ3 is located within project site.

49. As per Figure 4, two of the Noise Sampling Stations (NQ3 and NQ5) are located within the project site, therefore, noise level measurements from these two locations have been considered as a part of OHS noise monitoring as well as ambient noise monitoring. For the purpose of OHS monitoring, Leq have been calculated for 8 hours as reported in Table 24 and compared with ILO noise standards. Leq levels for 8-hour periods are in compliance with the ILO noise standard of 85 dBA.

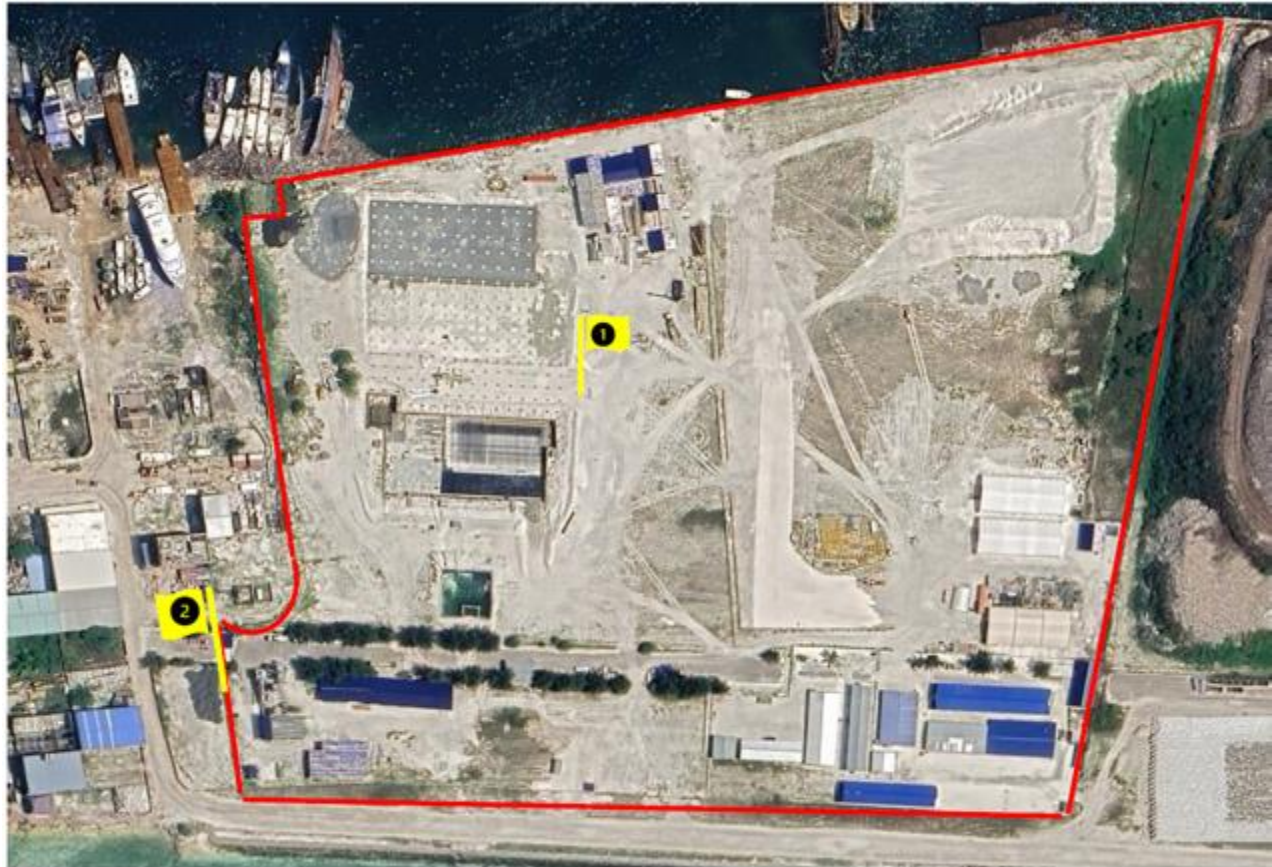
Figure 5: Ambient Air Quality Sampling Stations within Project Site

42. Ambient air quality monitoring was carried out in all months at two locations within the project site on 24 hourly basis and results are presented in Table 22.
43. below. Levels of PM 2.5 were found exceeding the WHO standards for ambient air quality at all sites. Also, 8 hourly permissible limits by OSHA for respirable dust and total dust exposure

1. AREA 12
2. Batching plant

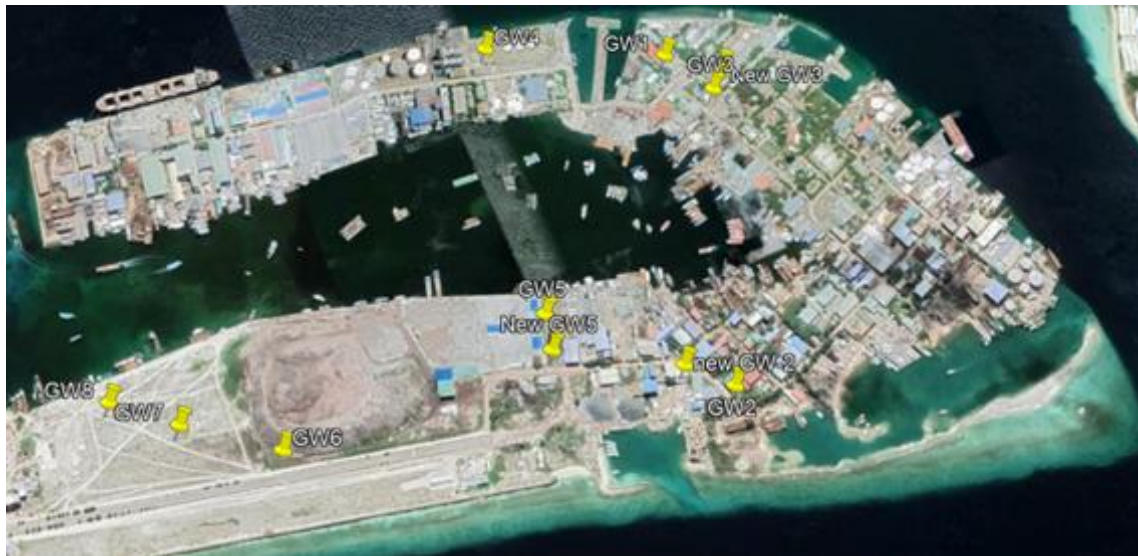
60. Environmental monitoring of groundwater quality for the construction period was conducted on 6th February 2025. Water samples were collected from the monitoring stations identified in the EIA (July 2020) except at GW6 (refer to Figure 7: Groundwater Sampling Stations Figure 7 for locations) due to non-accessibility of location GW5, sampling could not be carried out. For each location, the sample was collected from mid-water level and brought for laboratory testing in Sri Lanka. General sampling procedure involves washing the glass sampling bottles with water from the sampling points. For microbial tests, samples were collected in sterile glass bottles and tested in the laboratory of Male' Water and Sewerage Company (MWSC). Table 28 presents the analytical results of groundwater quality.

61. Results from Table 28 show that levels of heavy metals were found below detection limit while other parameters are: Electrical conductivity (444 $\mu\text{S}/\text{cm}$ at GW1 to 4650 $\mu\text{S}/\text{cm}$ at GW2), pH (7.7 at GW2 and 8.2 at GW3 and GW6) and nitrate (ND at GW1 and 1.4 mg/l at GW7). While PAH were reported ND at all locations. As use of ground water in Thilafushi is not permissible except in toilet flushing tanks there is no specific standard for ground water quality. Wells closer to the sea show high conductivity.

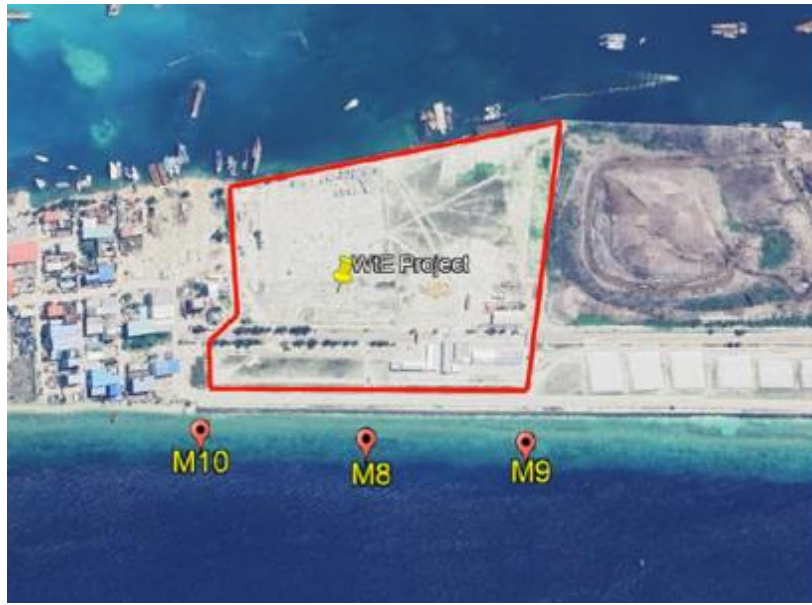
Figure 8 Marine Survey Locations

70. As part of site environmental baseline monitoring, the 6th marine ecological survey for reef benthic cover and fish population was conducted on 28th January 2025 in M10 (This location has been identified in the EIA report as a potential alternative for the discharge of brine water and waste water.), M9 (This location was identified as an alternative for brine discharge and wastewater outfall) and M8 (The site is the location that will be used for discharge of waste water from the brine outfall as described in the EIA) as seen in Figure 8 below.

71. A standard approach, established by the Maldives EIA community and approved by the Environmental Protection Agency (EPA), was employed to study benthic cover and fish populations. The survey employed GPS locations, transects surveys conducted at two depths: 5m and 10m at each station (M8, M9 and M10 – as detailed in an earlier report). The methods followed were those outlined by Hodgson et.al (2006) in Reef Check Instruction Manual: A Guide to Reef Check Coral Reef Monitoring. Three transects of 20 m length were laid, one after the other along the reef, ensuring the transect falls to the specific depth. A quadrant of size 0.5 x 0.5 m was laid sequentially on the transect, and photo images were taken with the quadrant in the center. Details of findings of survey are summarized below and report is enclosed as Appendix-4

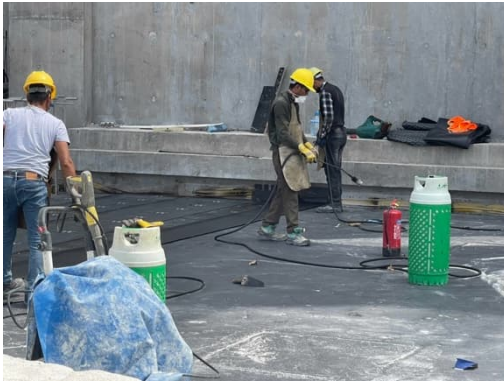
Figure 1: Workers laying the bitumen without wearing masks properly

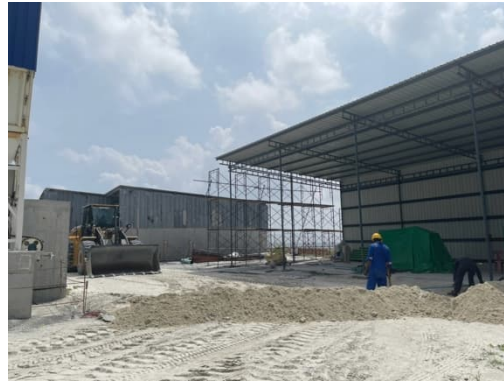
Figure 2: Batching plant area – Housing for RO Plant and genset, back has been closed off and new cable laying for the new genset

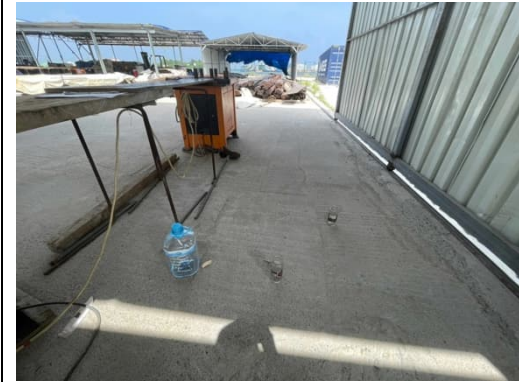
Figure 3: Potable water and glass jars

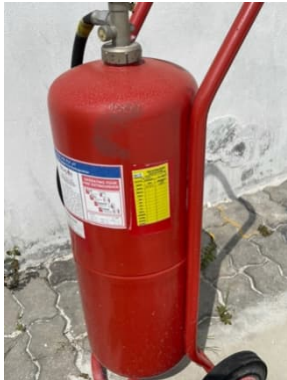
Figure 4: Fire extinguishers tested in January 2025

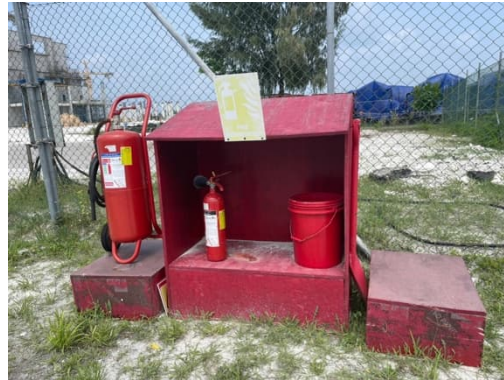
Figure 5: Fire extinguishers tested in January 2025

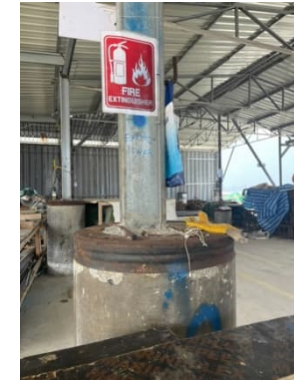
Figure 6: Fire extinguisher still missing from this site

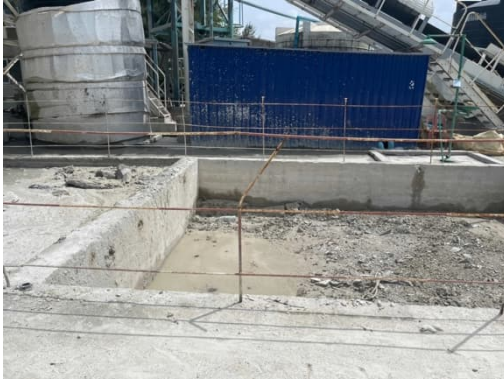
Figure 7: Waste concrete wash pits on two different visits

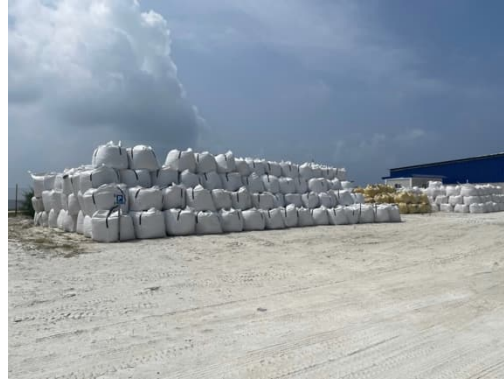
Figure 8: Stockpiles of materials for the batching plant and the yellow jumbos with waste concrete to be disposed

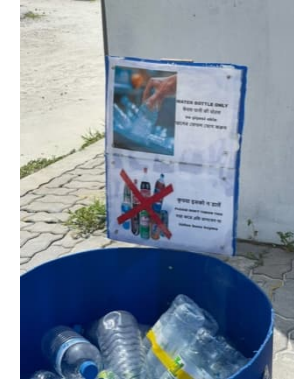
Figure 9: Plastic interception activities

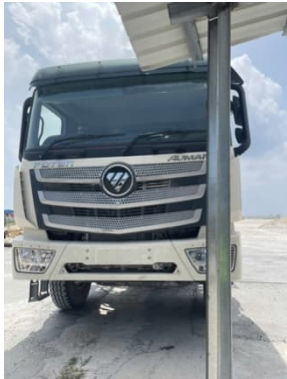
Figure 10: Registration permits of the vehicles pending

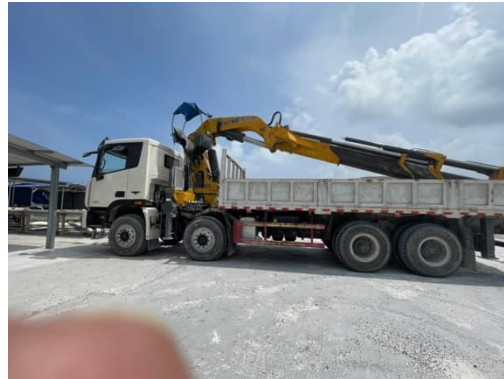
Figure 11: Registration process of the vehicles needs to be updates

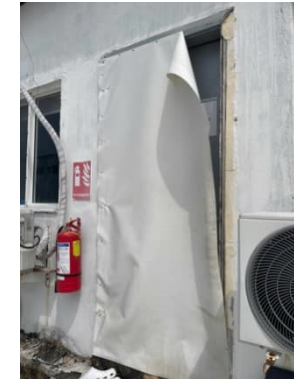
Figure 12: Workers rooms door covered to protect from rain

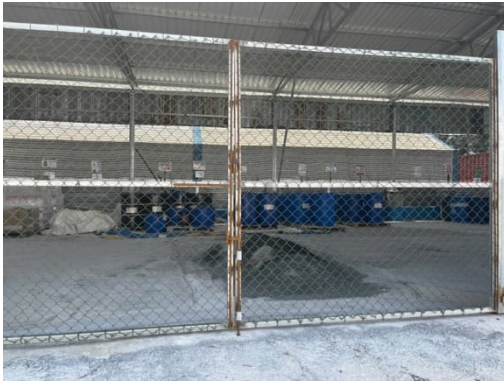
Figure 13. Gates fixed at the Chemical storage warehouse

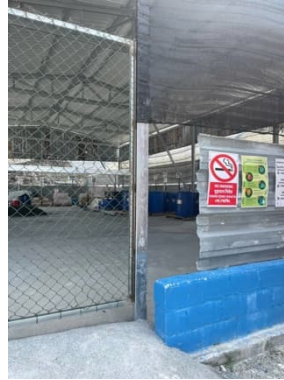
Figure 14. An accesible gap between the gate and the warehouse fence needs to be sealed off.

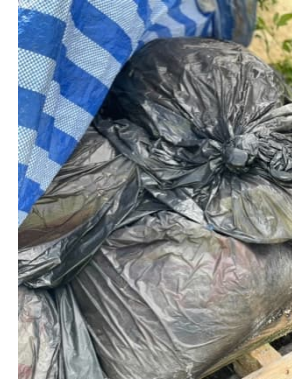
Figure 15. Sludge still kept in bags

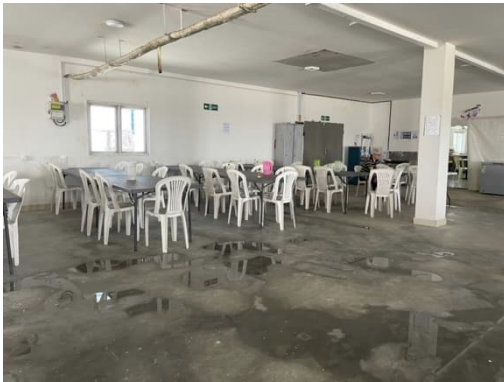
Fig. 16 Workers Mess room washed and cleaned

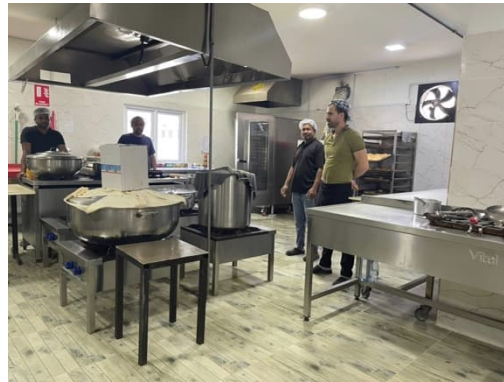
Fig. 17 Kitchen all in order

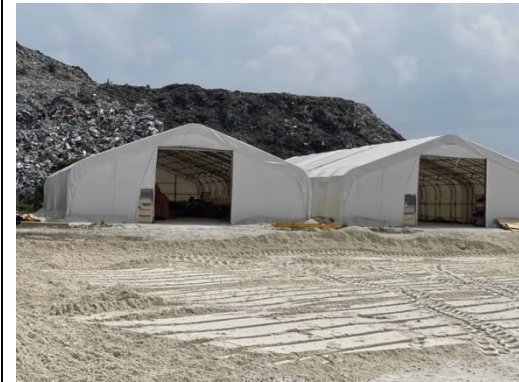
Fig 18. View of the waste mound after the fall off

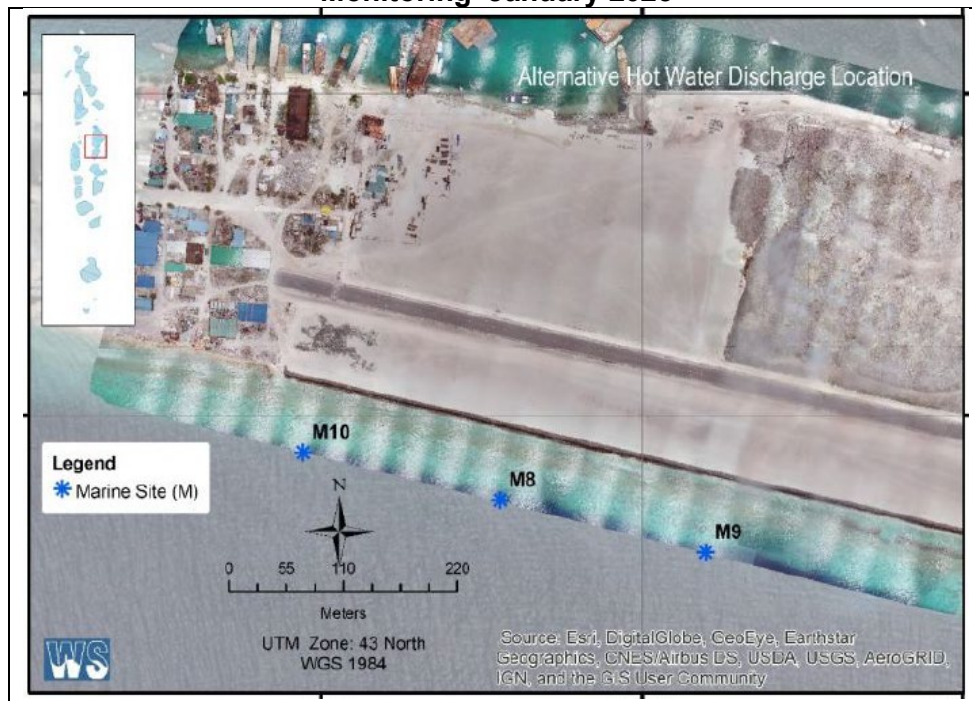
Figure 1: Underwater Marine Survey Locations M8,M9 and M10 for construction stage Monitoring January 2025

For the construction site environmental monitoring reef benthic 8th survey was conducted 28th January 2025 in locations M10, M9 and M8 **Figure 1**. The purpose of the marine survey was to continue monitoring changes to the conditions established in the Environmental Impact Assessment (EIA) during August and September 2018. A re-evaluation of the baseline was established in June 2022, and the first monitoring survey was conducted on 24th December 2022 and the following report is based on the 8th survey conducted on 28th January 2025.

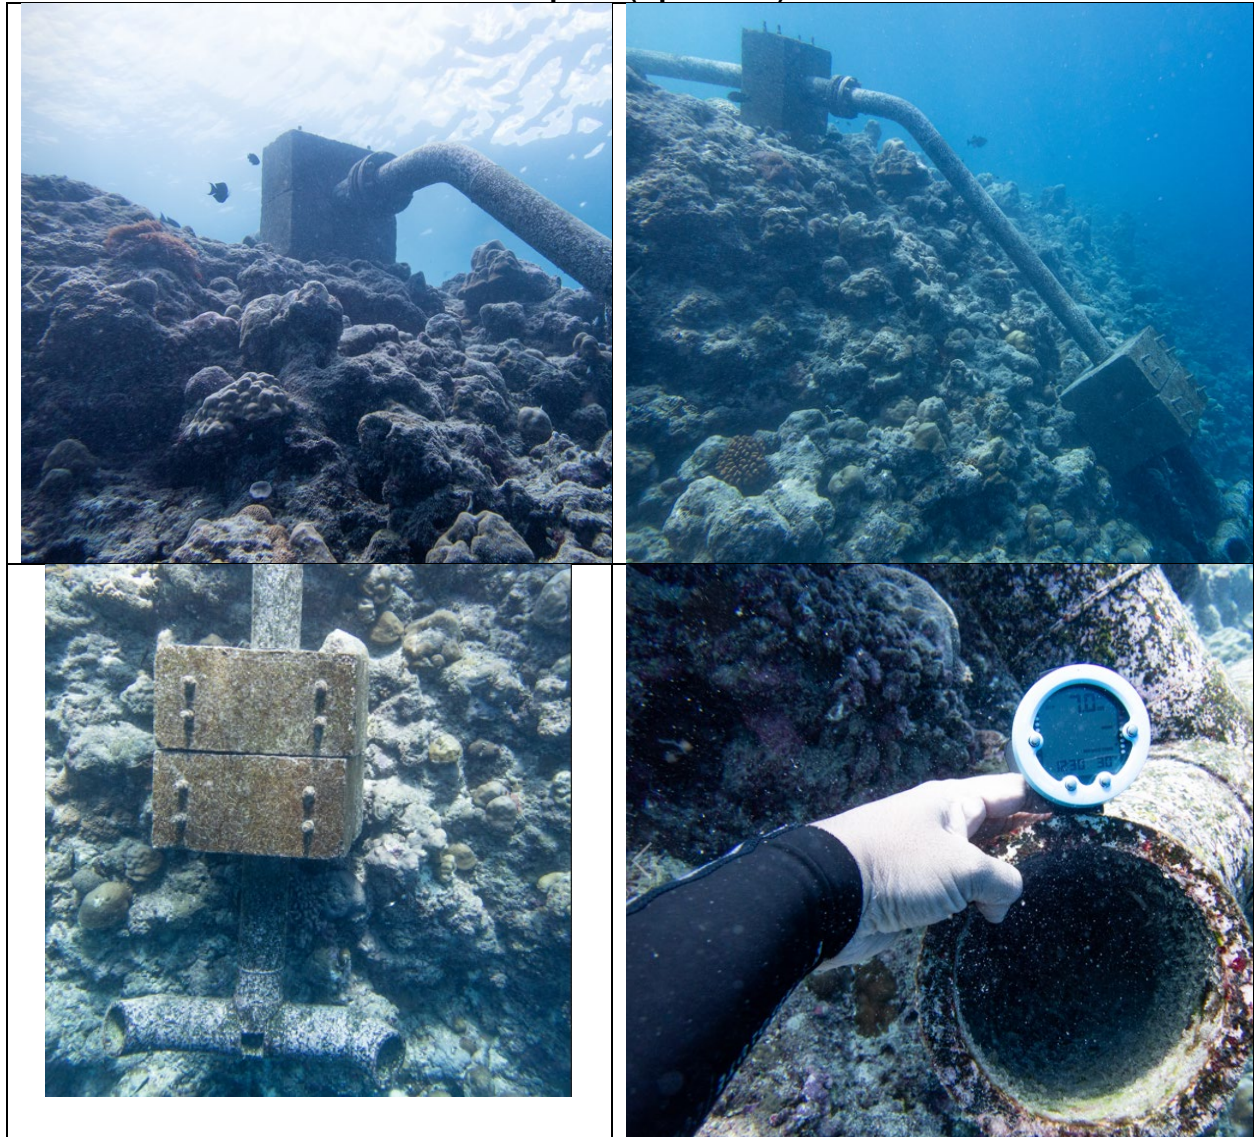
Figure 2. Waste water outfall pipe installed at M8 discharging from temporary waste water plant (April 2023).

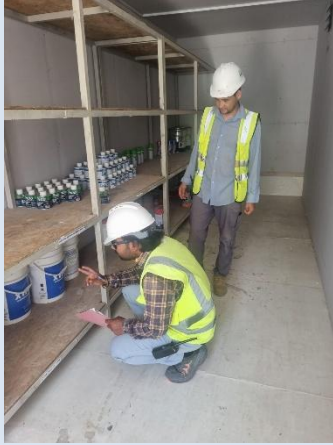
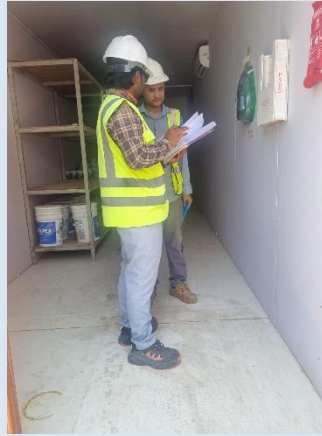
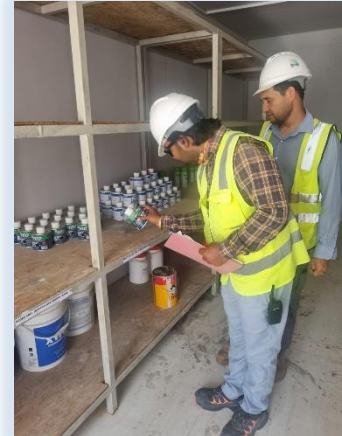
7.1 CHEMICAL STORE INSPECTION

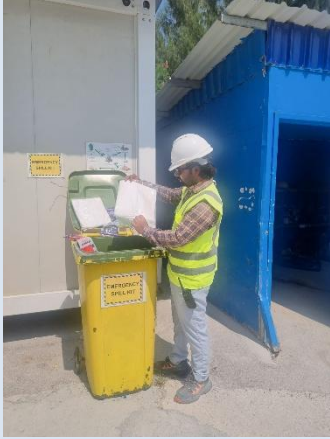
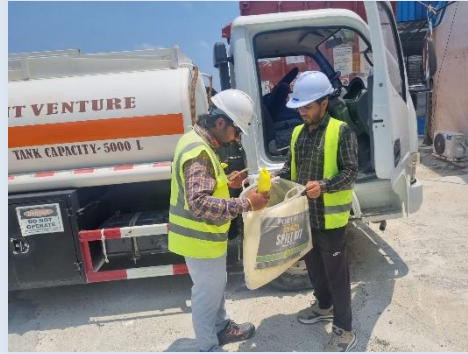
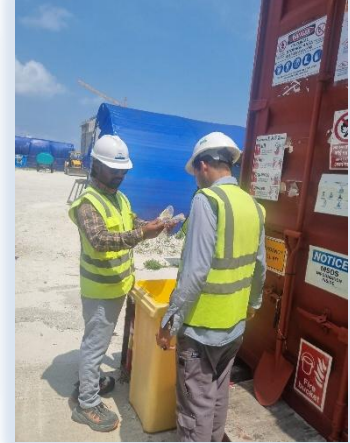
7.2 SPILL KIT INSPECTION

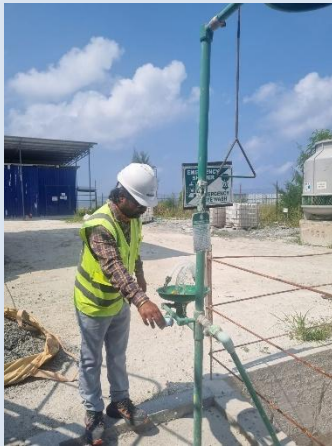
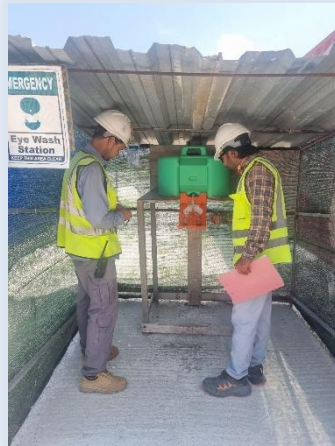
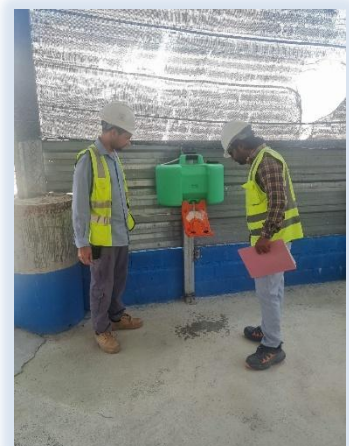
7.3 EYE WASH & SHOWER
